# Concerns with Fire Safety in Hidden Inaccessible Areas

**Gus Sarkos**

Manager, Fire Safety Section  
FAA Wm. J. Hughes Tech. Ctr.  
Atlantic City Airport, NJ

ATSRAC Meeting  
January 23 – 24, 2002  
Atlanta, Georgia

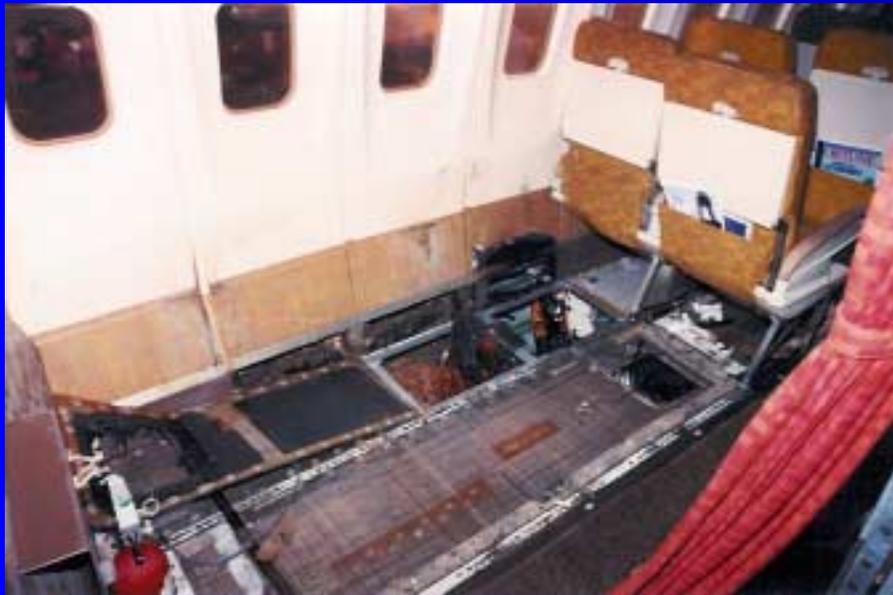
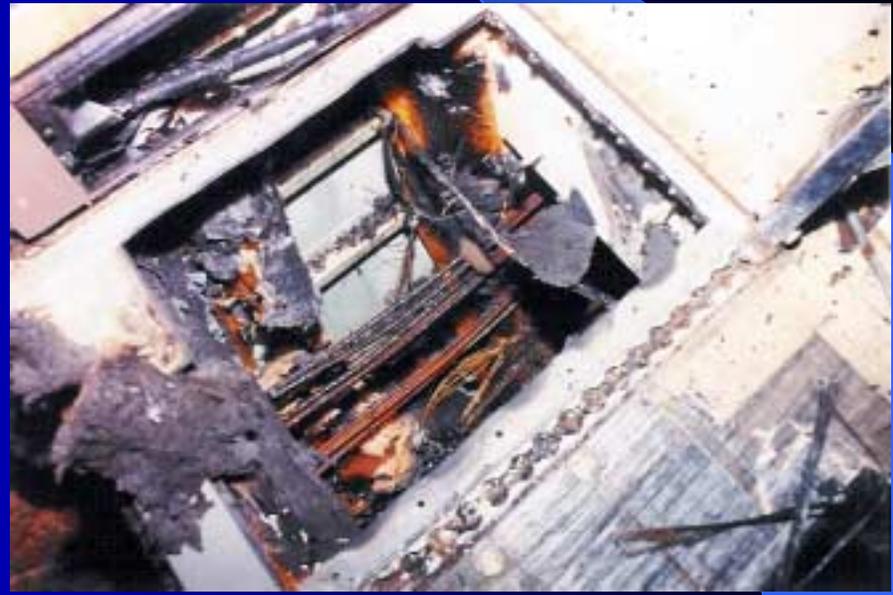
# Delta

- Contamination causes materials to be more flammable
- Includes lint, dust, combustion inhibiting compounds, etc.
- Classic Example (Delta L-1011, 3/17/91)
  - In flight fire enroute Frankfurt to Atlanta
  - Fire started below floor and spread up sidewall
  - Extinguished with Halon 1211

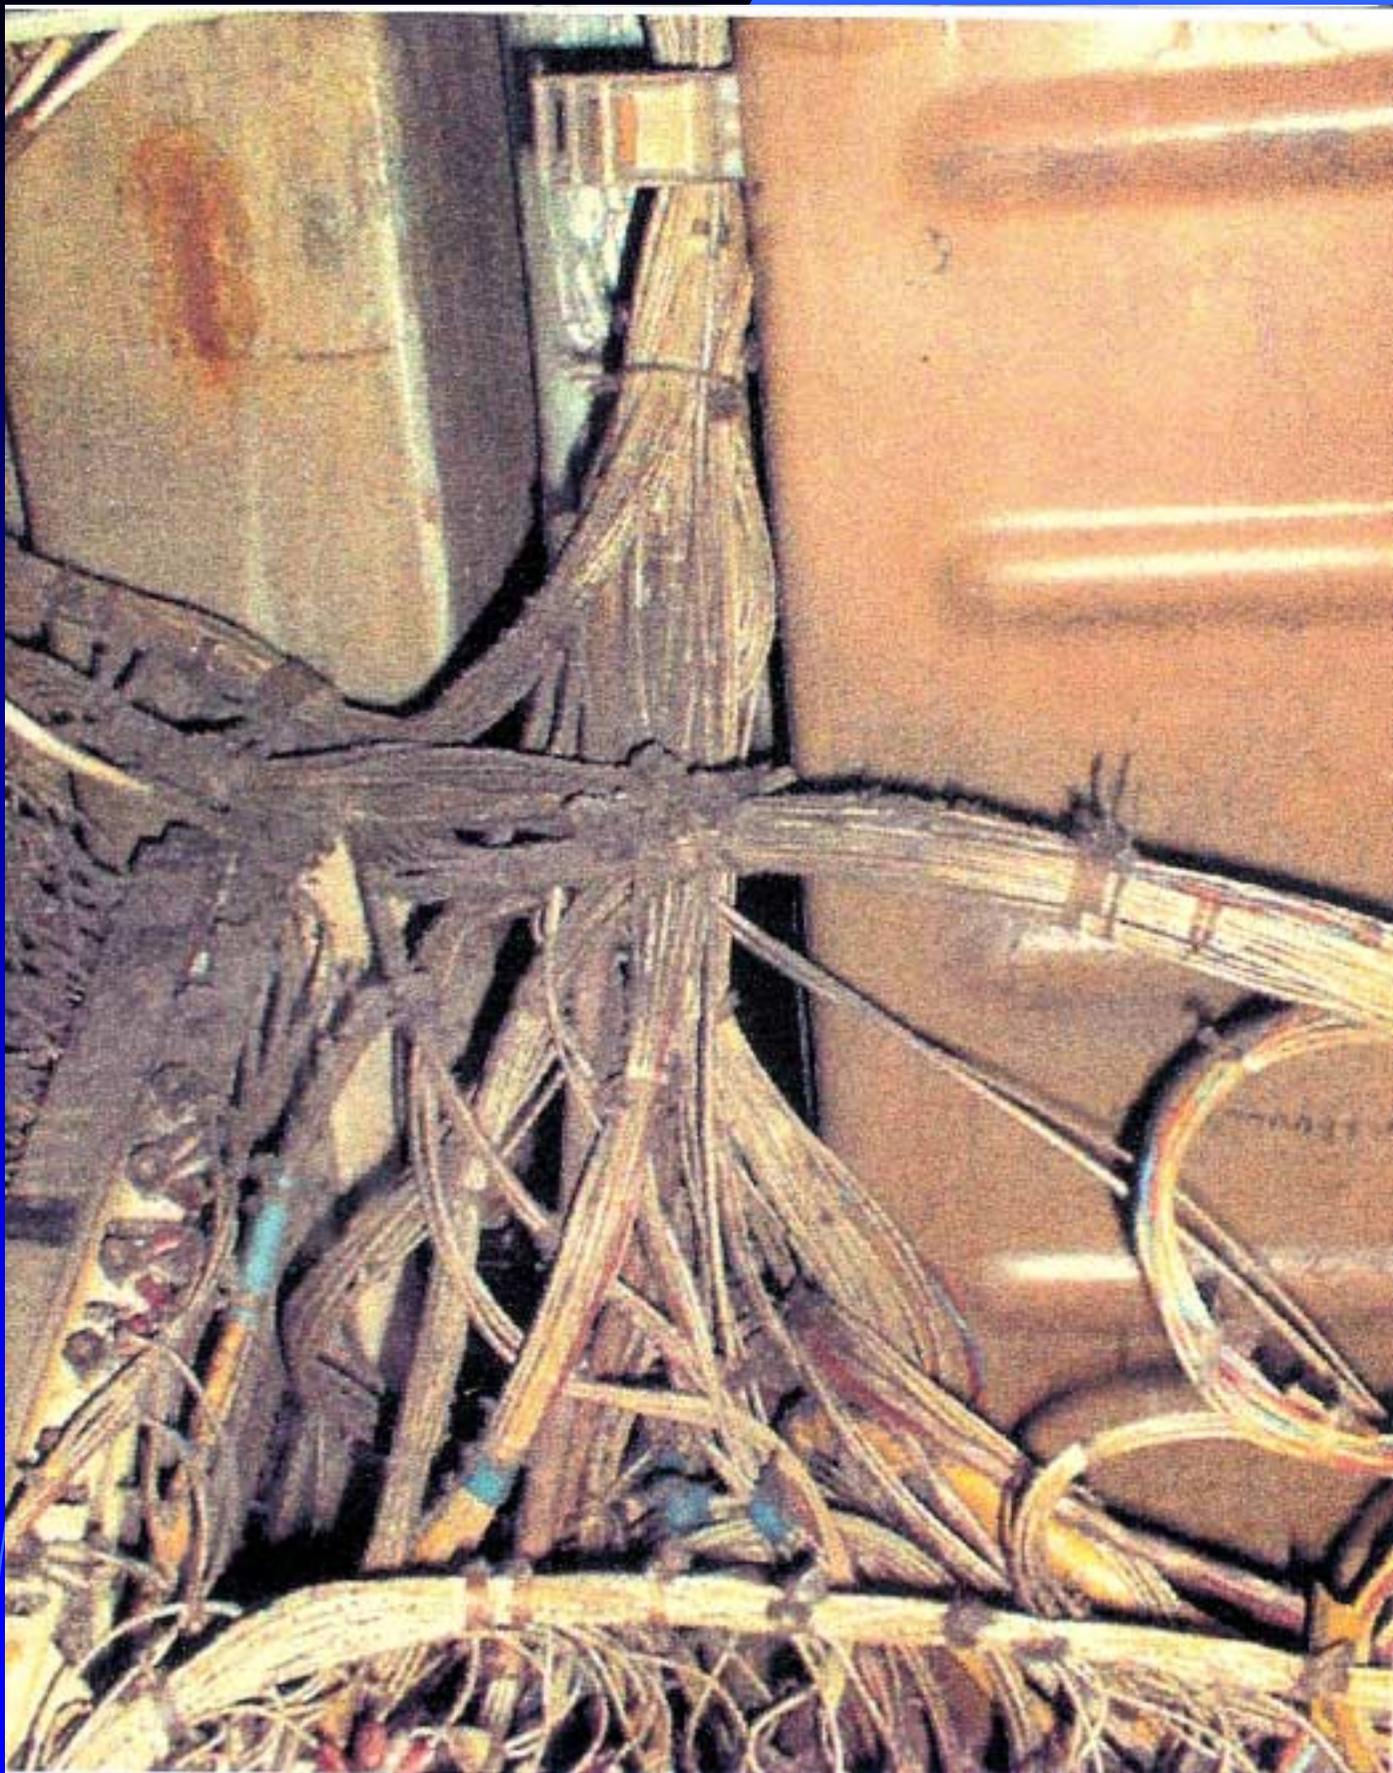
- TSB/NTSB Concerns with Contamination
  - Significant: 3/8 inch average; over 2 inches in some areas
  - Contamination also found in random inspection of other aircraft
  - Recommended changes in maintenance to address

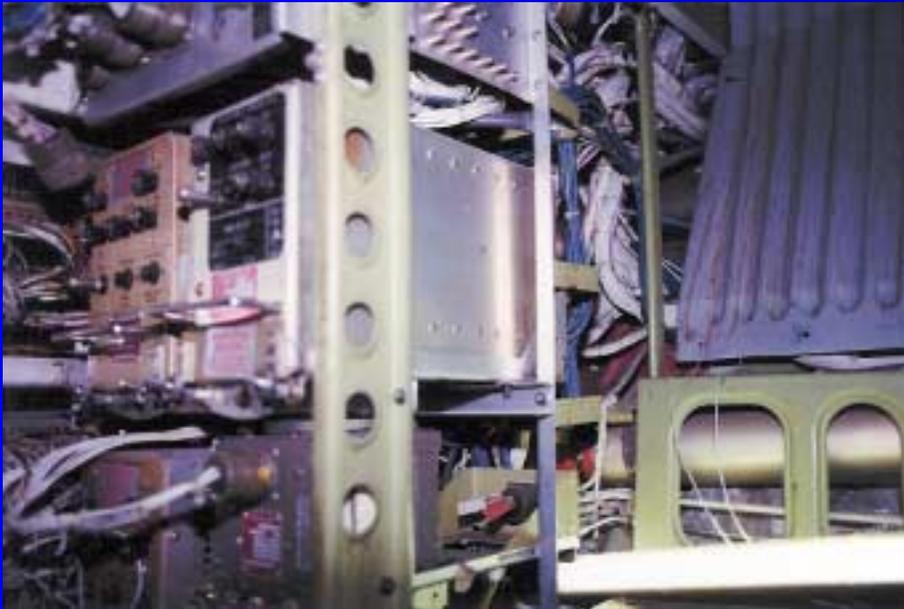
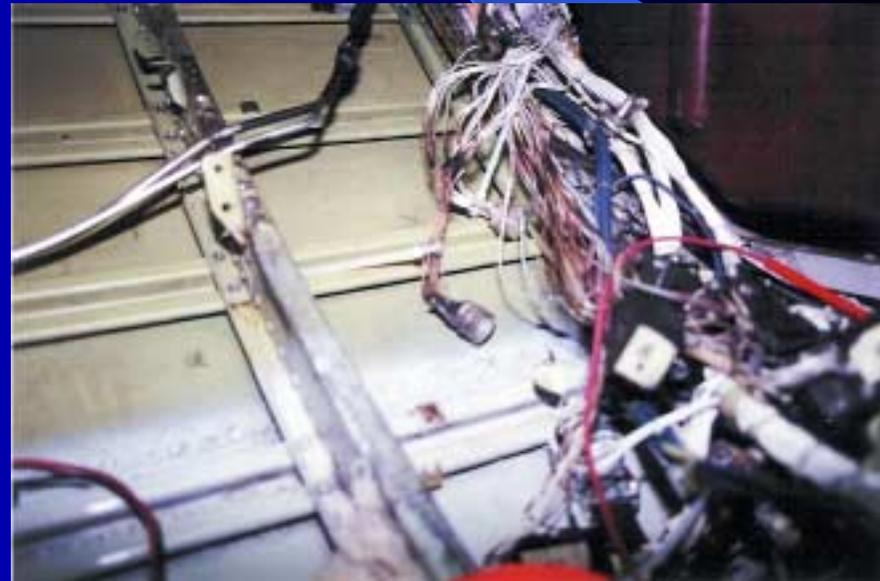
US Air  
MD-80  
Buffalo, NY  
January 18, 1990

- Past FAA Fire Tests (DOT/FAA/CT-91/2)
  - Insulation without CIC Self-Extinguishing
  - Insulation with CIC Burned Completely
- CIC Residue found on materials
- Concern: Enhanced material flammability caused by contamination
