Intrusive Inspection Project Report to ATSRAC

**Christopher Smith, Chairman
Intrusive Inspection Working Group**

October 11, 2000

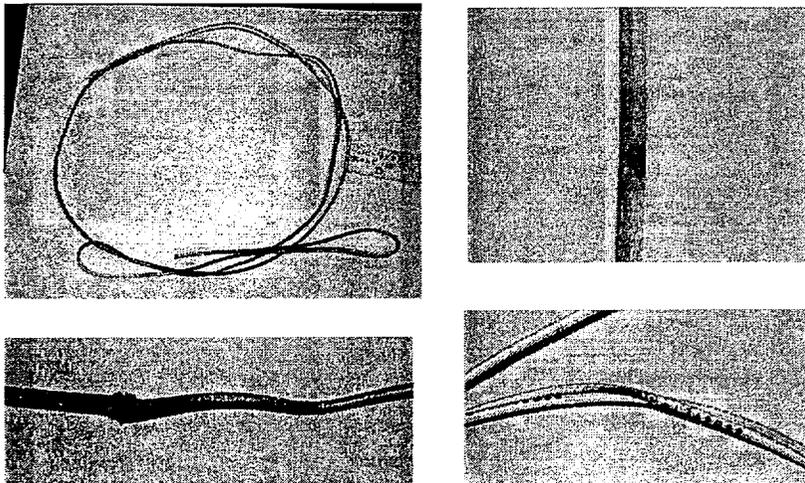
Typical Findings: DC-9 "Tired Wire"

- DC-9(2): Burnt wire beneath spiral wrap in aft tail cone on corresponding wire bundles on either side of the aft stair. (Inspectors generally characterized wire in this zone as "very tired", probably as a result of excessive and prolonged exposure to heat.) There was no evidence of the burn on the spiral wrap leading us to believe that failure was internally generated (e.g. an intermittent short between wires).

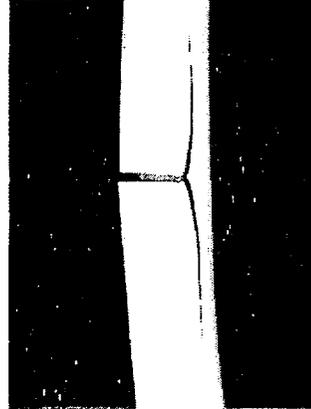
Typical Findings: 747

- 747: White feeder cable worn to conductor and riding on copper feeder cable (in good condition).
- DC-9(2): Blackening and severe embrittlement of wires leading to wing tip lighting at both wing tips. There was some speculation that this might be due to wing-tip light modifications which resulted in higher electrical loads than design would tolerate.

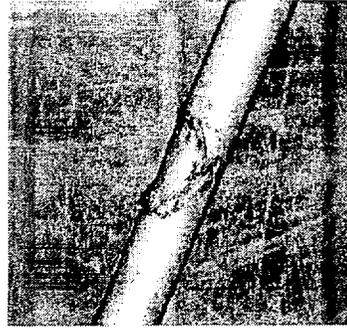
Typical Findings: L1011

- **Polyimide:** Instance of delamination were observed on the A300 and L1011.
- **PVC/Glass/Nylon:** Substantial degradation of wire on one the two DC-9 aircraft (cracking, thermal degradation).
- **Poly-X:** Characteristic radial cracking.
- **ETFE:** Relatively good condition, but with some signs of dielectric performance degradation.
