# SPECIAL AIRWORTHINESS INFORMATION BULLETIN

No. NE-02-22  
March 26, 2002

This Special Airworthiness Information Bulletin (SAIB) alerts you, operators, repair stations and principal maintenance inspectors (PMI's) of cracks found in Pratt & Whitney JT8D-200 series high pressure compressor (HPC) front hubs (C-8) hubs. We want to present background information, identify the affected configurations, and provide recommendations for operators to incorporate into their continuous airworthiness maintenance programs.

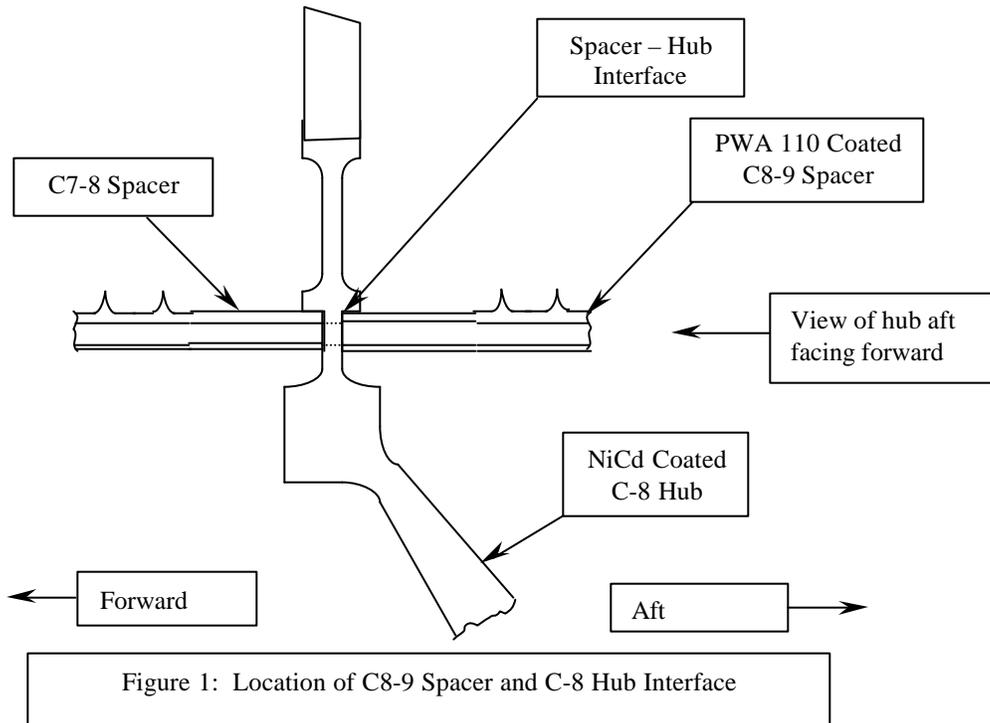
Cracks have been found in JT8D-200 series C-8 hubs on the rear face of the tierrod hole. The cracks are occurring at the interface of the C-8 hub and the stage 8<sup>th</sup> to 9<sup>th</sup> spacer (C8-9 spacer). To date, 16 cracked hubs have been found. The cause of the cracking appears to be fretting induced fatigue. The fretting is believed to be the result of spalling of the PWA-110 coating in the spacer-hub interface as a result of normal relative motion between the hub and the spacer. The spalled coating material, trapped between the hub and spacer, produces high contact stresses which results in the fretting and ultimately cracking of the hub. Because of this cracking mechanism, cracks have only been found on configurations that incorporate PWA-110 coating on the spacer and Nickel-Cadmium (NiCd) coating on the hub. This configuration has been the production configuration for JT8D-217C's and JT8D-219's since 1987. It is unclear at this time whether the same mechanism occurs on a PWA-110 coated hub combined with a PWA-110 coated spacer. It is reasonable to assume that the same mechanism may exist with a PWA-110 coated spacer on a PWA-110 coated hub configuration, however more inspection data is needed for this configuration.

Figure 1: Location of C8-9 Spacer and C-8 Hub Interface

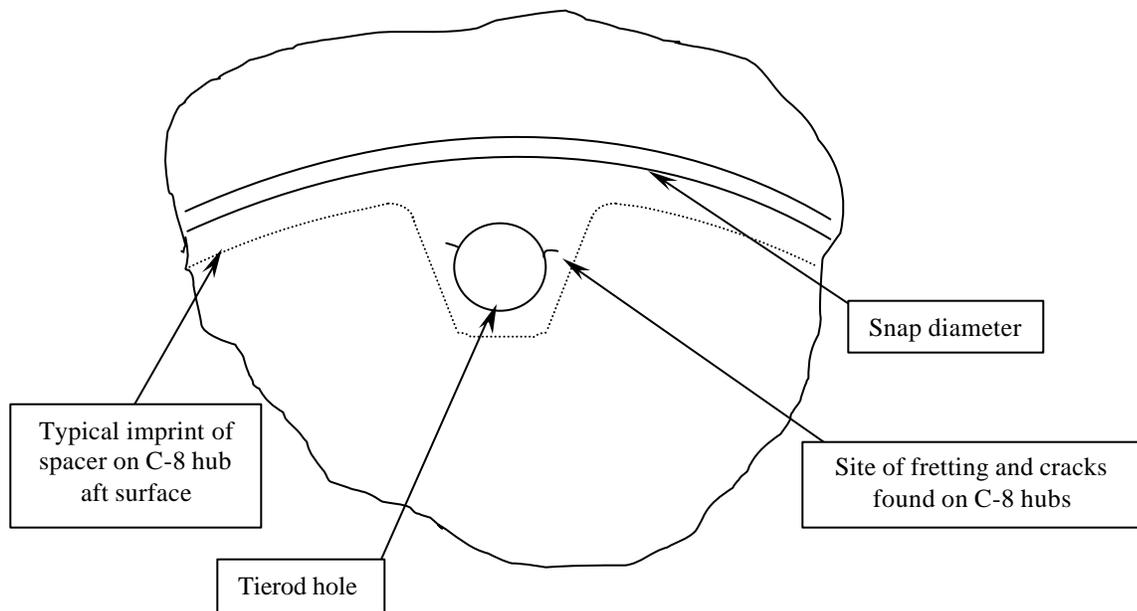
The cracked hubs are typically found on high-time HPC's; all exceeded 13,000 cycles in service since new or since last HPC overhaul. The cracks appear in the aft face of the hub between the 9 to 11 o'clock and 1 to 3 o'clock positions adjacent to the tierrod holes. The clock position on the tierrod hole is defined by viewing the hub from the aft facing forward with 12 o'clock located on the tierrod hole circumference nearest the OD of the hub. Figure 1 illustrates the location of the spacer-hub interface where cracks are found on the C-8 hubs. Figure 2 shows the typical locations of the cracks relative to the tierrod hole.

Figure 2: Location of Fretting and Cracks Found on Aft Face of C-8 Hubs

2. Review your current C-8 hub fluorescent magnetic particle inspection (FMPI) techniques to be sure that they establish the correct magnetic fields to find cracks in the circumferential orientation. Refer to PW Engine Manual PN 773128, section 72-36-42, inspection -03 and PW Standard Practices Manual, Service Process Operation Procedure (SPOP) 115, step E.

3. Institute focused visual and FMPI inspections in the area of the hubs susceptible to fretting and cracking when the hubs become available in the shop (refer to NDIP 1052 contained in AOW C2009-G63027 XFR.)
